TECHNICAL REPORT H-77-22

BREAKWATER STABILITY STUDY IMPERIAL BEACH, CALIFORNIA

Hydraulic Model Investigation

Prepared for U. S. Army Engineer District, Los Angeles
Los Angeles, California 90053

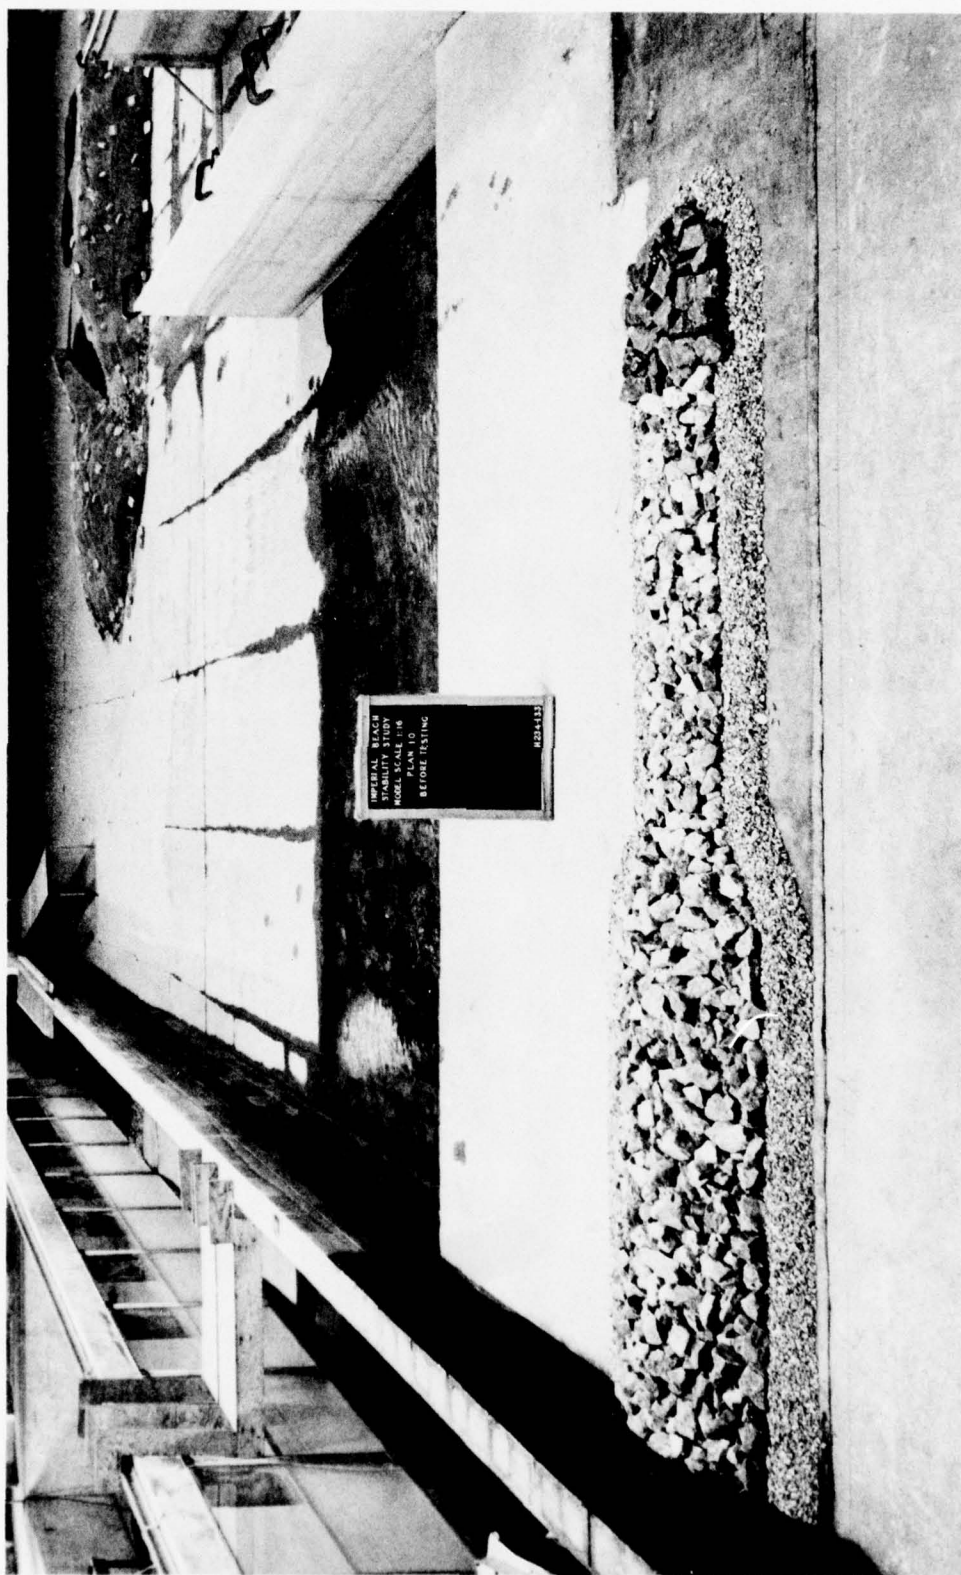
Photo 45. Sea-side view of Plan 10 before wave attack

24. Plan 10 (Plate 13 and Photo 45) was initiated based on the marginally acceptable test results of Plan 9. Like Plan 7C, Plan 10, in the deeper water location, consisted of alternating high- and low-sill sections with 1V-on-2H side slopes constructed of 5.0- and 3.0-ton graded armor stone, respectively. A 2-ft-thick, 5-ft-wide berm of 25-lb filter stone was placed at the beach-side and sea-side toes of the high-sill section and low-sill trunk. The purpose of this material would be to hold the exposed filter cloth in place and to help prevent undermining of toe areas in the prototype. The low-sill head's 7.0-ton armor stone (one layer) was placed on a 2-ft-thick bed of 25-lb filter stone which was to be underlaid by filter cloth in the prototype. This filter layer prevented the direct placement of 7.0-ton armor stone on the filter cloth. Crown elevations of 0.0, -5.0, and -3.0 ft mllw were used on the high-sill section, low-sill trunk, and low-sill head, respectively. After 2.0 hr of attack by 14.0-sec, 8.3-ft waves at an swl of 0.0 ft mllw caused minor instability of the breakwater (Photo 46). The test condition was changed to 14.0-sec, 12.1-ft waves at an swl of +5.4 ft mllw. After 2.0 hr of exposure, the high-sill section and low-sill trunk showed moderate damage and the low-sill head had accrued extensive damage (Photo 47).

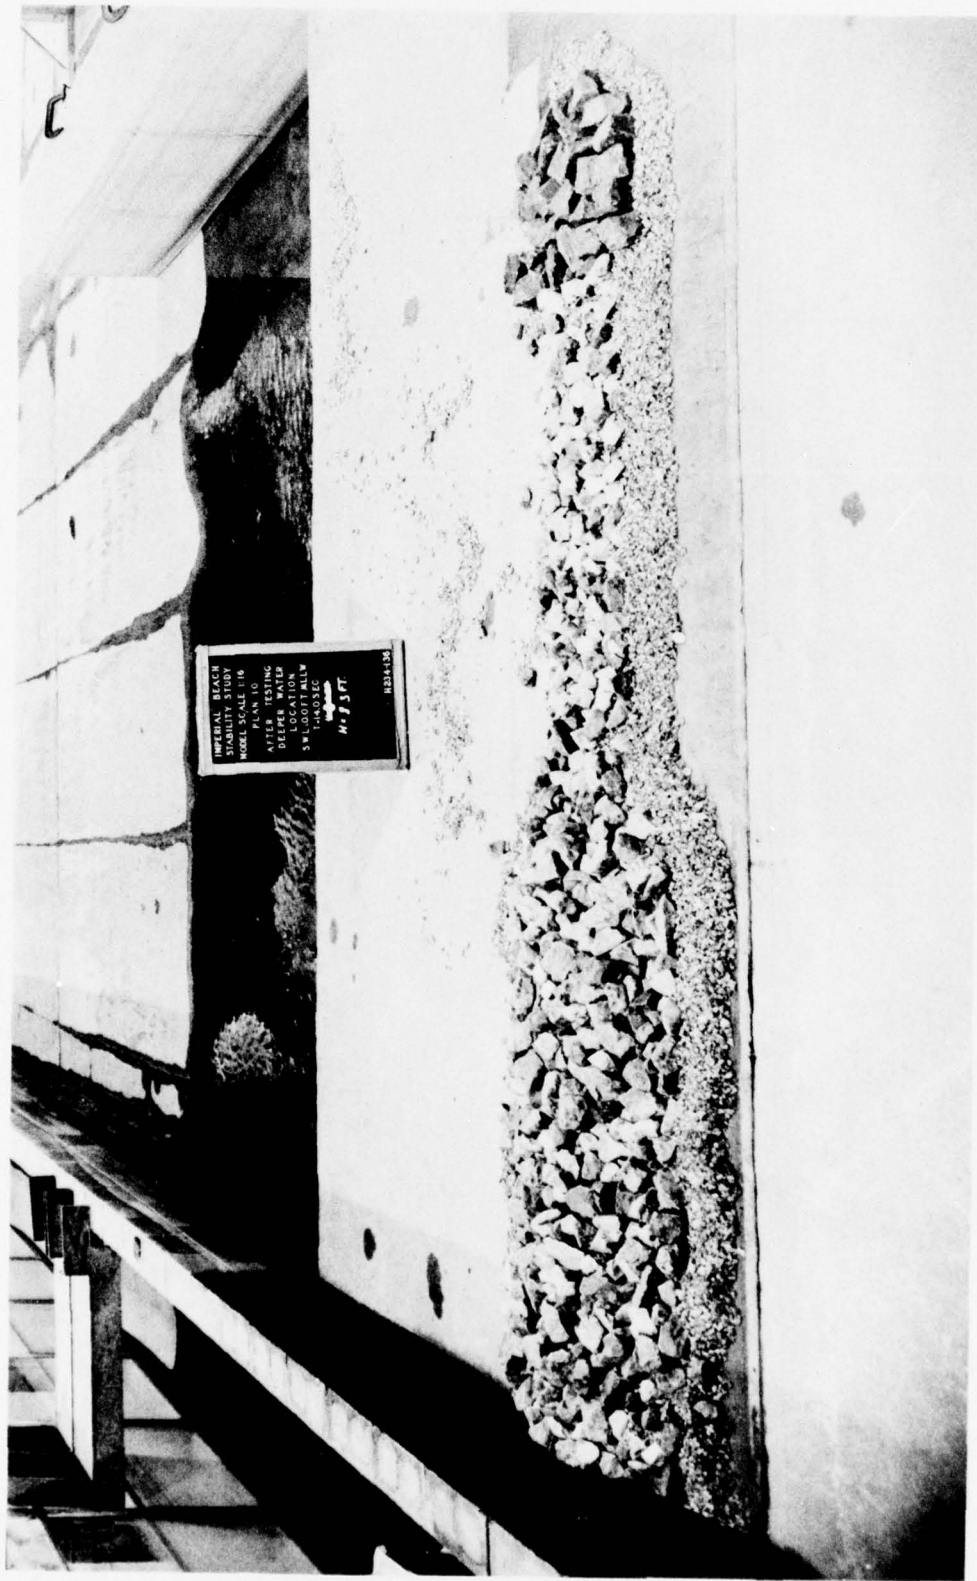
Photo 46. Sea-side view of Plan 10 in the deeper water location after 2.0 hr of 14.0-sec, 8.3-ft waves at an swl of 0.0 ft mllw

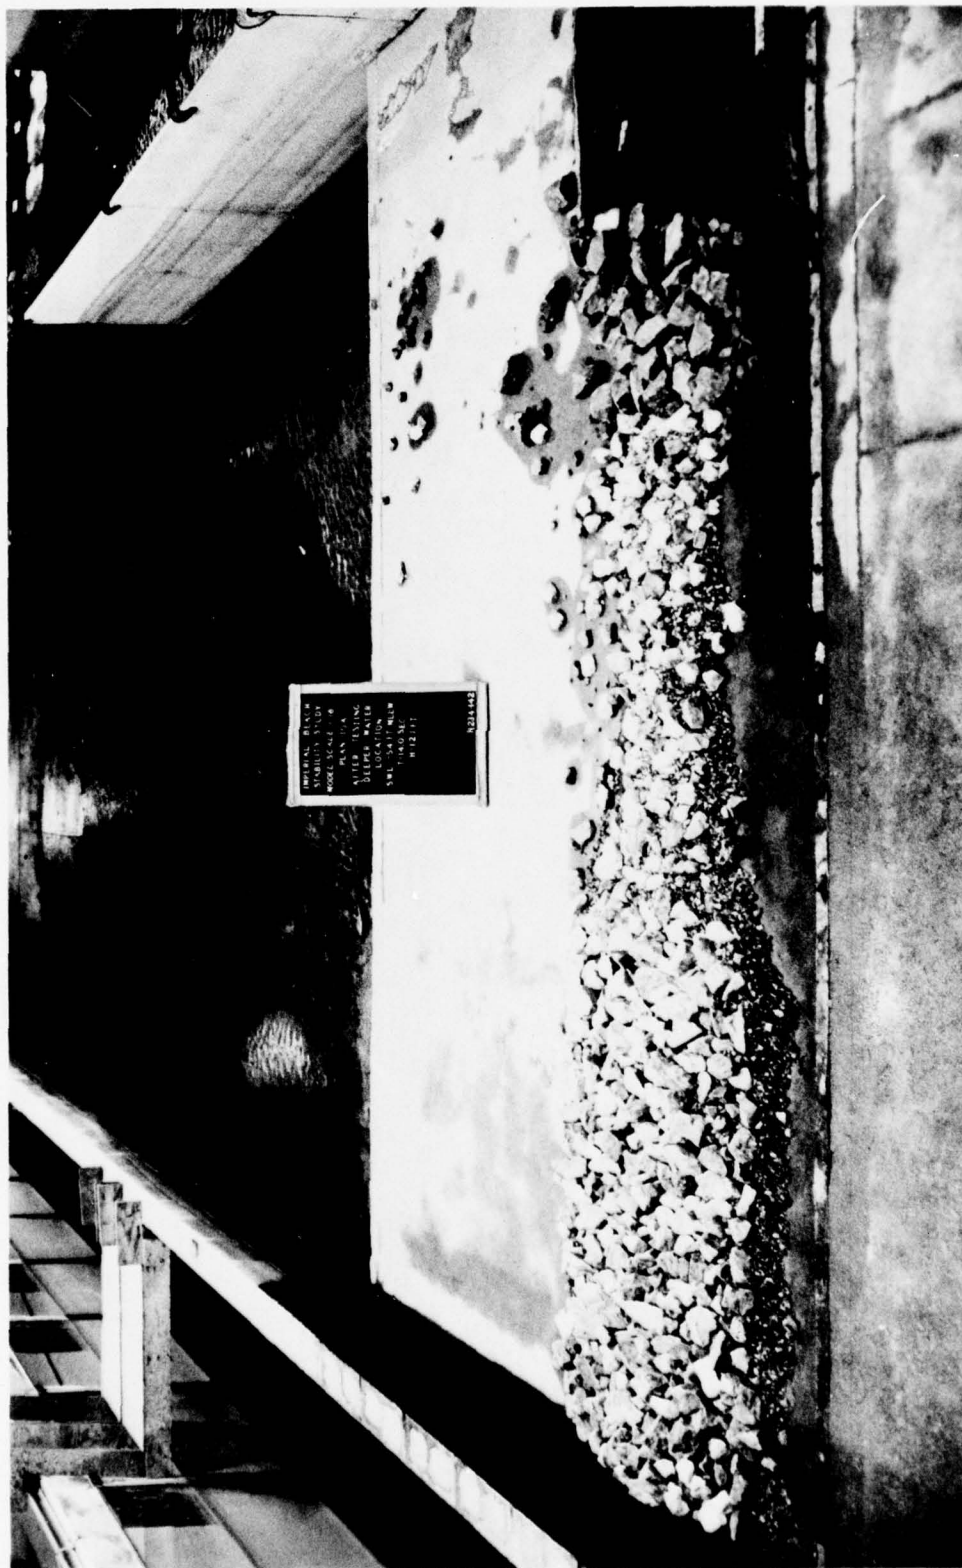
Photo 48. Sea-side view of Plan 10A in the deeper water location after 2.0 hr on the low-sill head and 4.0 hr on the remainder of the breakwater of 14.0-sec, 12.1-ft waves at an swl of +5.4 ft mllw

extensive damage of the low-sill head of Plan 10. For this reason it was replaced by one layer (2 ft thick) of 1000-lb stone. The remainder of the structure was not rebuilt after testing Plan 10. After 2.0 hr more of attack by 14.0-sec, 12.1-ft waves at an swl of +5.4 ft mllw, the low-sill head and trunk showed extensive damage. Movement on the high-sill section had lowered the crown elevation significantly. Damage had not stabilized but had exceeded the allowable amount when the test was stopped (Photo 48).

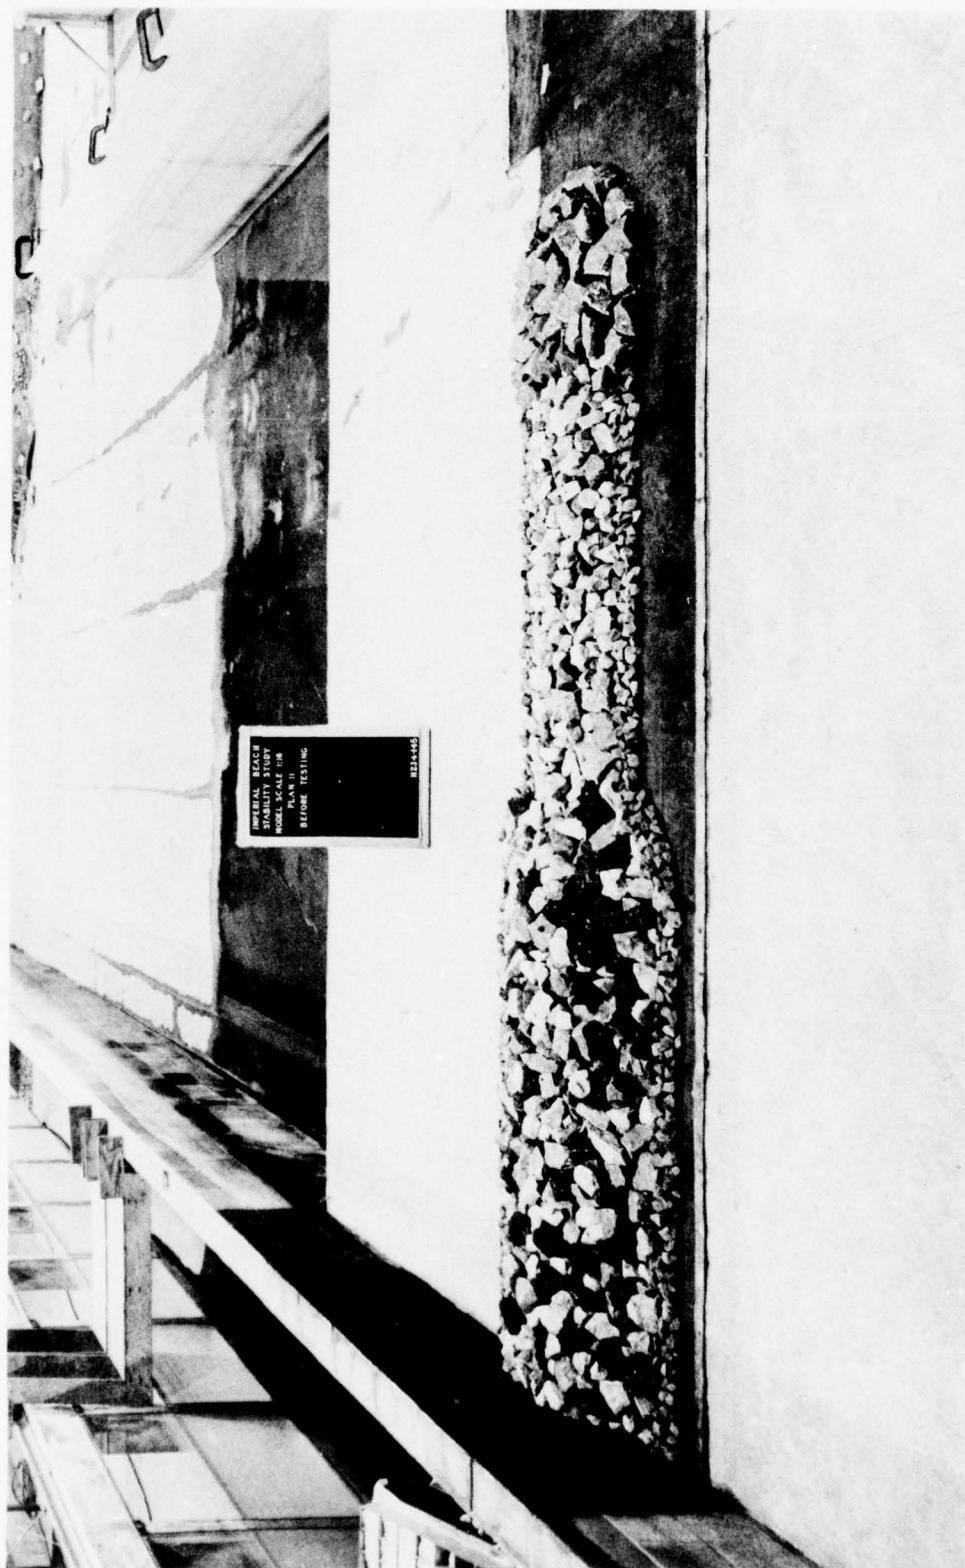
Photo 49. Sea-side view of Plan 11 before wave attack

26. Plan 11 (Plate 15 and Photo 49) used the alternating high- and low-sill concept. Results of Plans 10 and 10A (paragraphs 24 and 25) had shown that the 5.0- and 3.0-ton graded armor stone mixes constructed to 1V-on-2H slopes on the high and low sills, respectively, were unstable for the design condition of 14.0-sec, 12.1-ft waves at an swl of +5.4 ft mllw. Plan 11 incorporated the same design geometry for the high-sill section and low-sill trunk as used for Plans 10 and 10A; however, the weight of the graded armor stone mixes was increased. The 7-ton graded armor stone (given in Plate 15 and Table 1) was used on the high-sill section and 5.0-ton graded armor stone was used on the low-sill trunk. Maximum and minimum porosity of the 7-ton-graded armor stone as determined in the model was 47 and 40 percent, respectively. Like Plan 10A, a 6-ft-wide and 2-ft-high berm of 1000-lb stone was placed on both the sea-side and beach-side toe of the structure. The low-sill head and adjacent 15 ft of trunk were constructed using one layer of 7.0-ton armor stone placed on a 2-ft-thick layer of 1000-lb stone, except for the outer perimeter where 7.0-ton stones were to be placed directly on the filter cloth to stabilize the toe of the low-sill head which had proved unstable during testing of Plan 10A. Crown elevations were 0.0, -5.0, and -3.0 ft mllw for the high-sill section, low-sill trunk, and low-sill head, respectively. After 1.0 hr of exposure to 14.0-sec, 8.3-ft waves at an swl of 0.0 ft mllw, minor displacement of the beach-side berm had occurred (Photo 50). The condition was changed to 14.0-sec, 12.1-ft waves at an swl of +5.4 ft mllw. After 2.0 hr of wave attack, displacement of some of the beach-side toe stone behind the low-sill trunk section had occurred, but it is believed that the

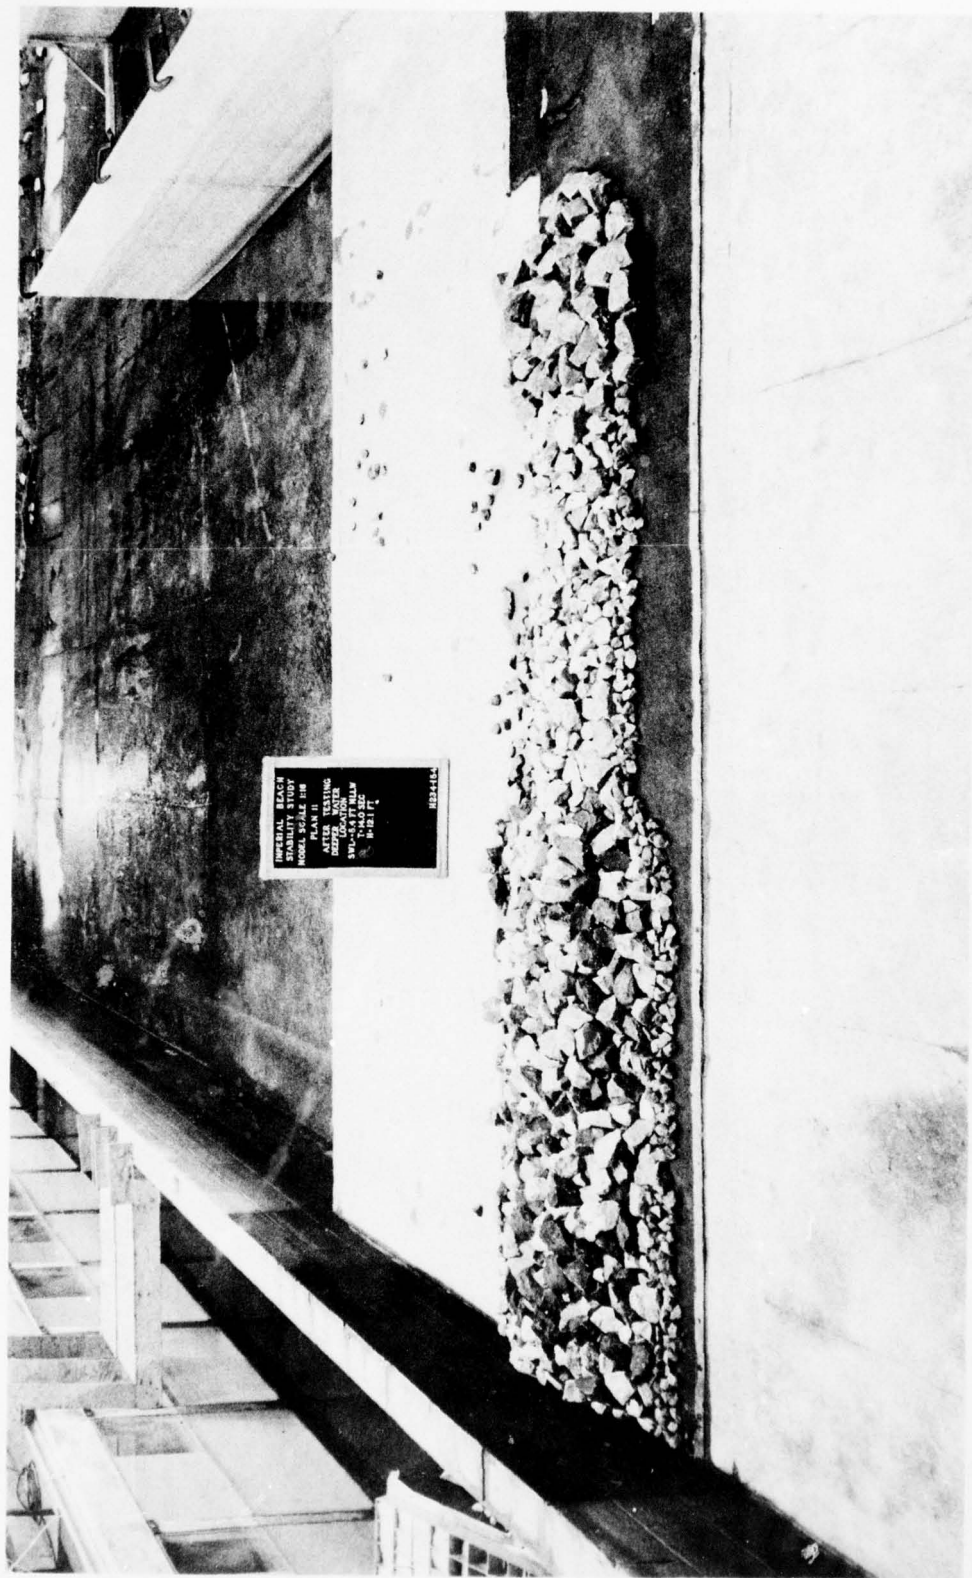
Photo 52. Sea-side view of Plan 11 in the deeper water location after 4.0 hr of 14.0-sec, 12.1-ft waves at an swl of +5.4 ft mllw

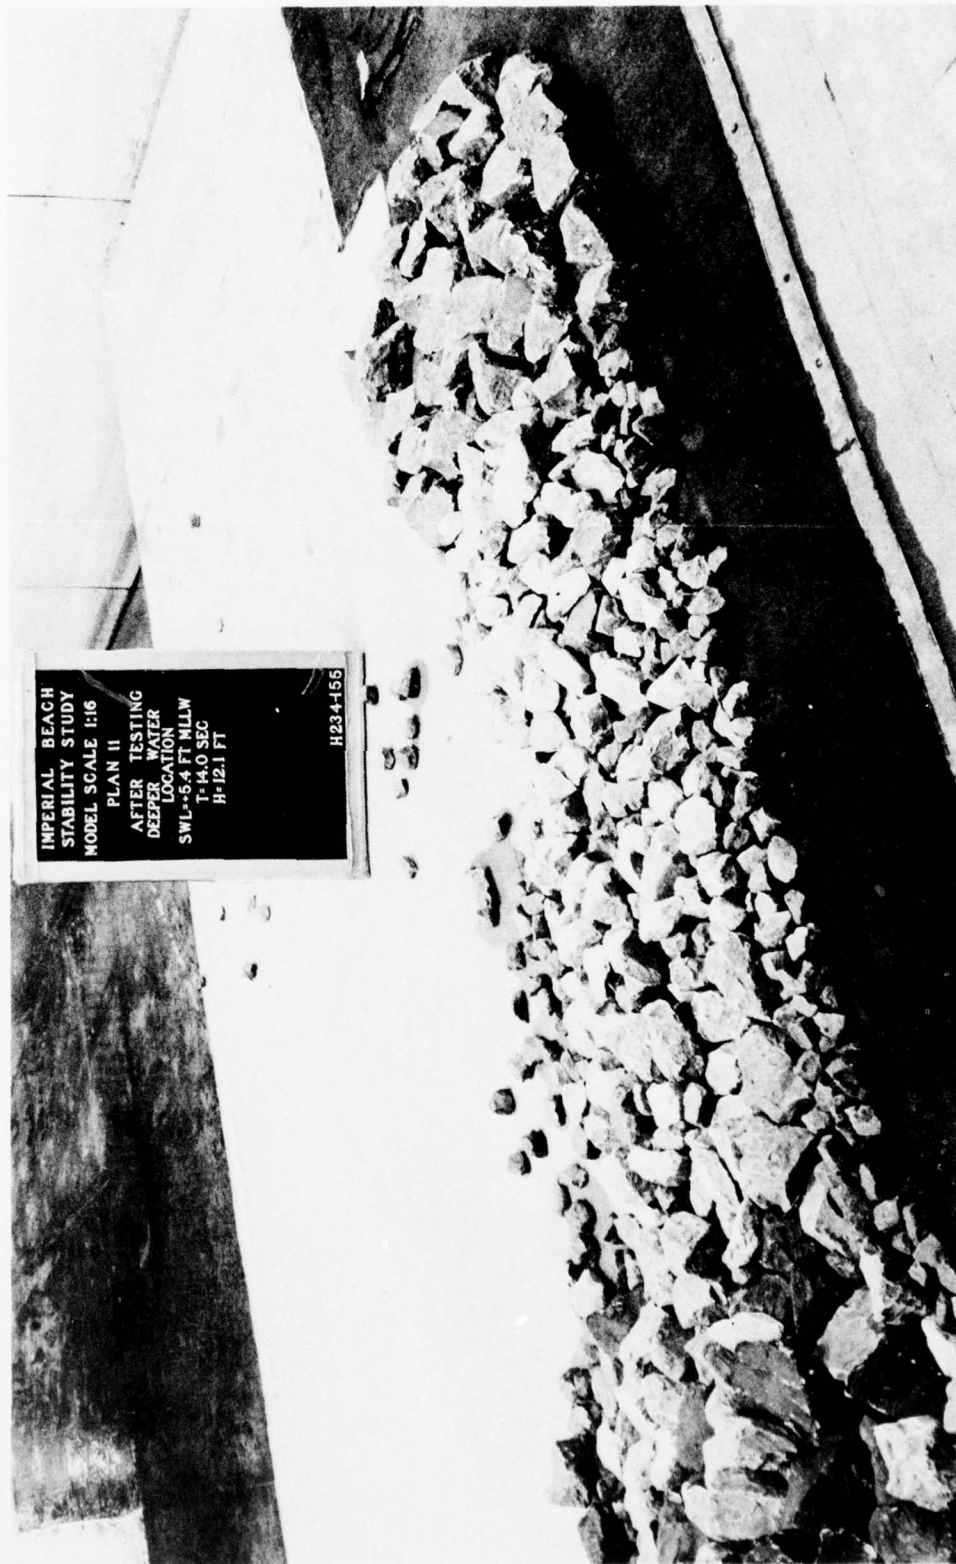
Photo 53. Sea-side view of low-sill section of Plan 11 in the deeper water location after 4.0 hr of 14.0-sec, 12.1-ft waves at an swl of +5.4 ft mllw

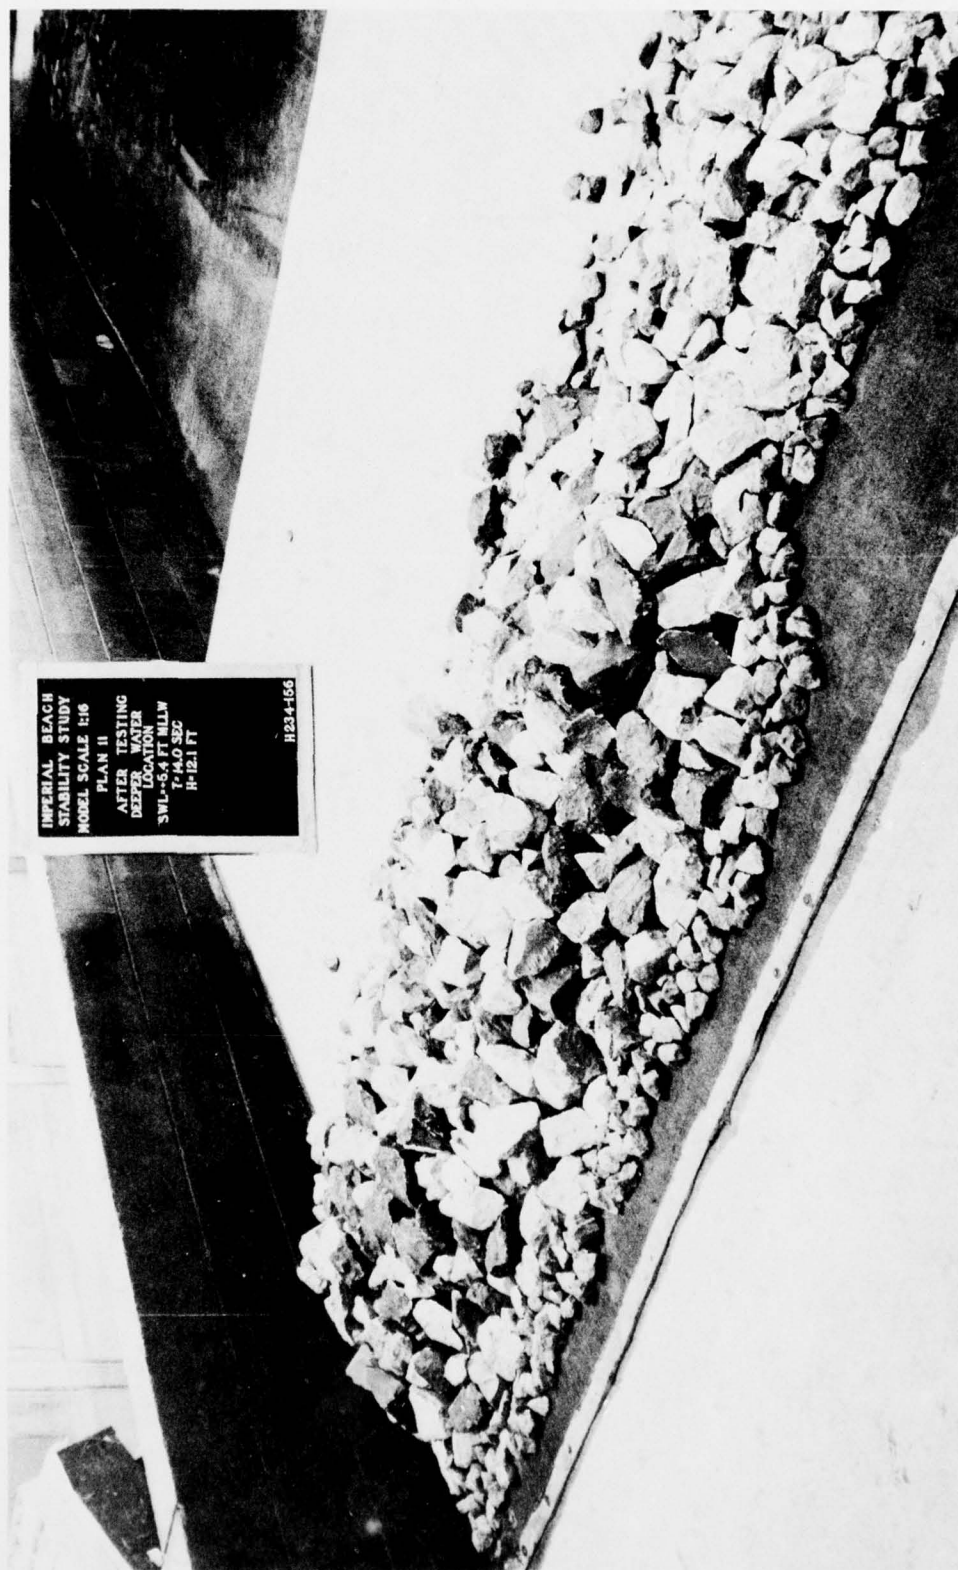
Photo 54. Sea-side view of high-sill section of Plan 11 in the deeper water location after
4.0 hr of 14.0-sec, 12.1-ft waves at an swl of +5.4 ft mllw

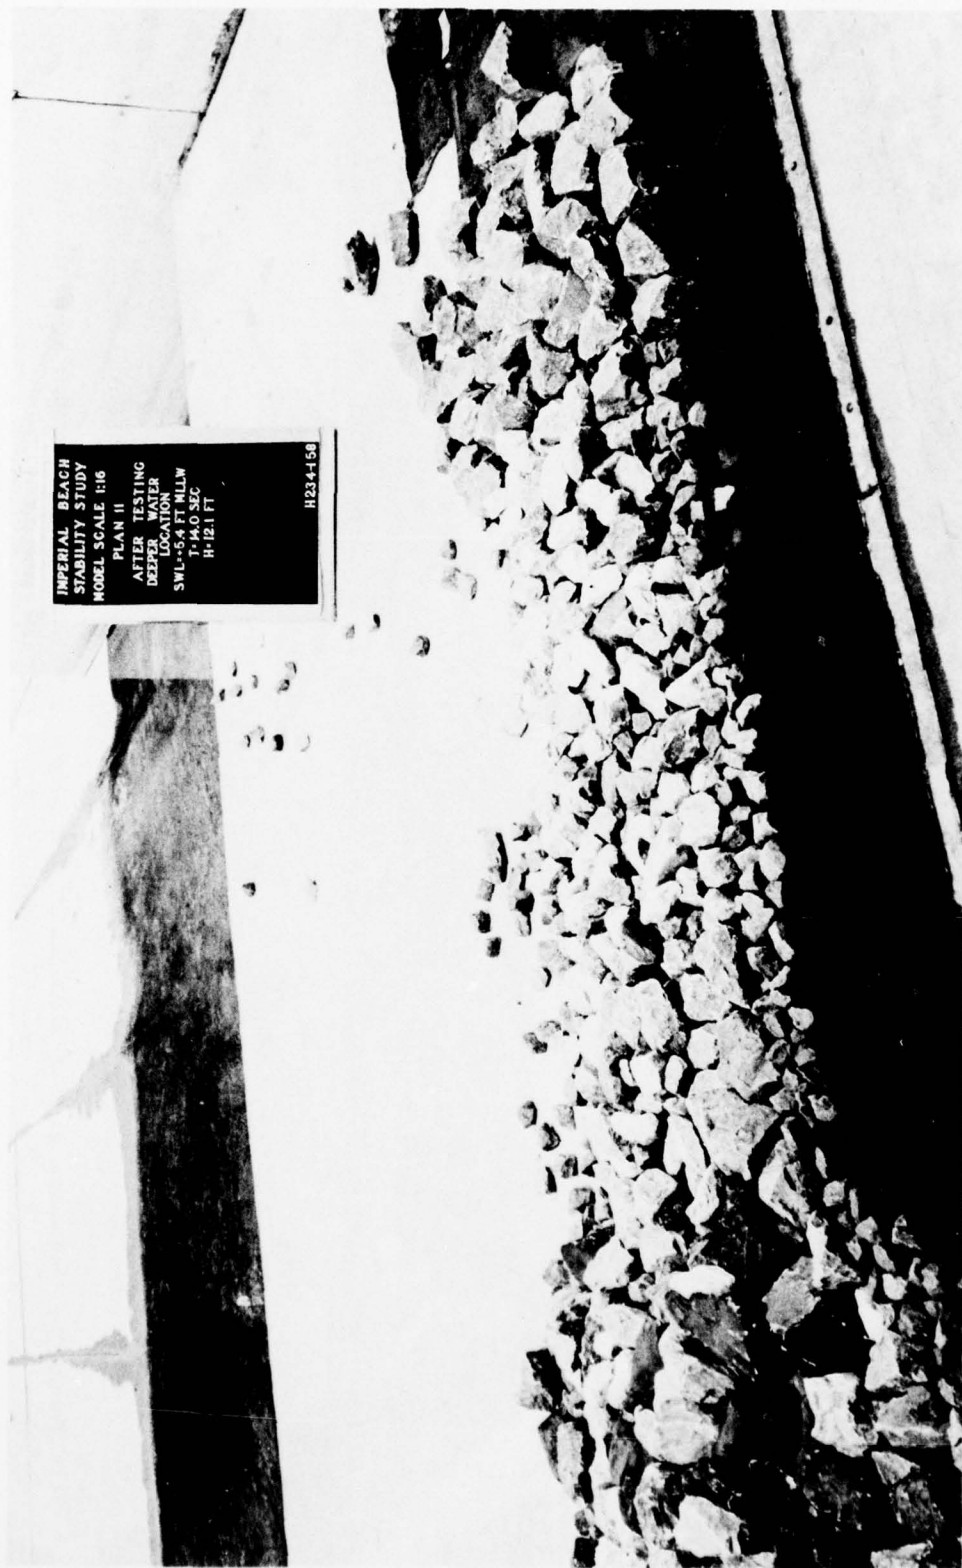
Photo 56. Sea-side view of low-sill section of Plan 11 in the deeper water location after 6.0 hr of 14.0-sec, 12.1-ft waves at an swl of +5.4 ft mllw

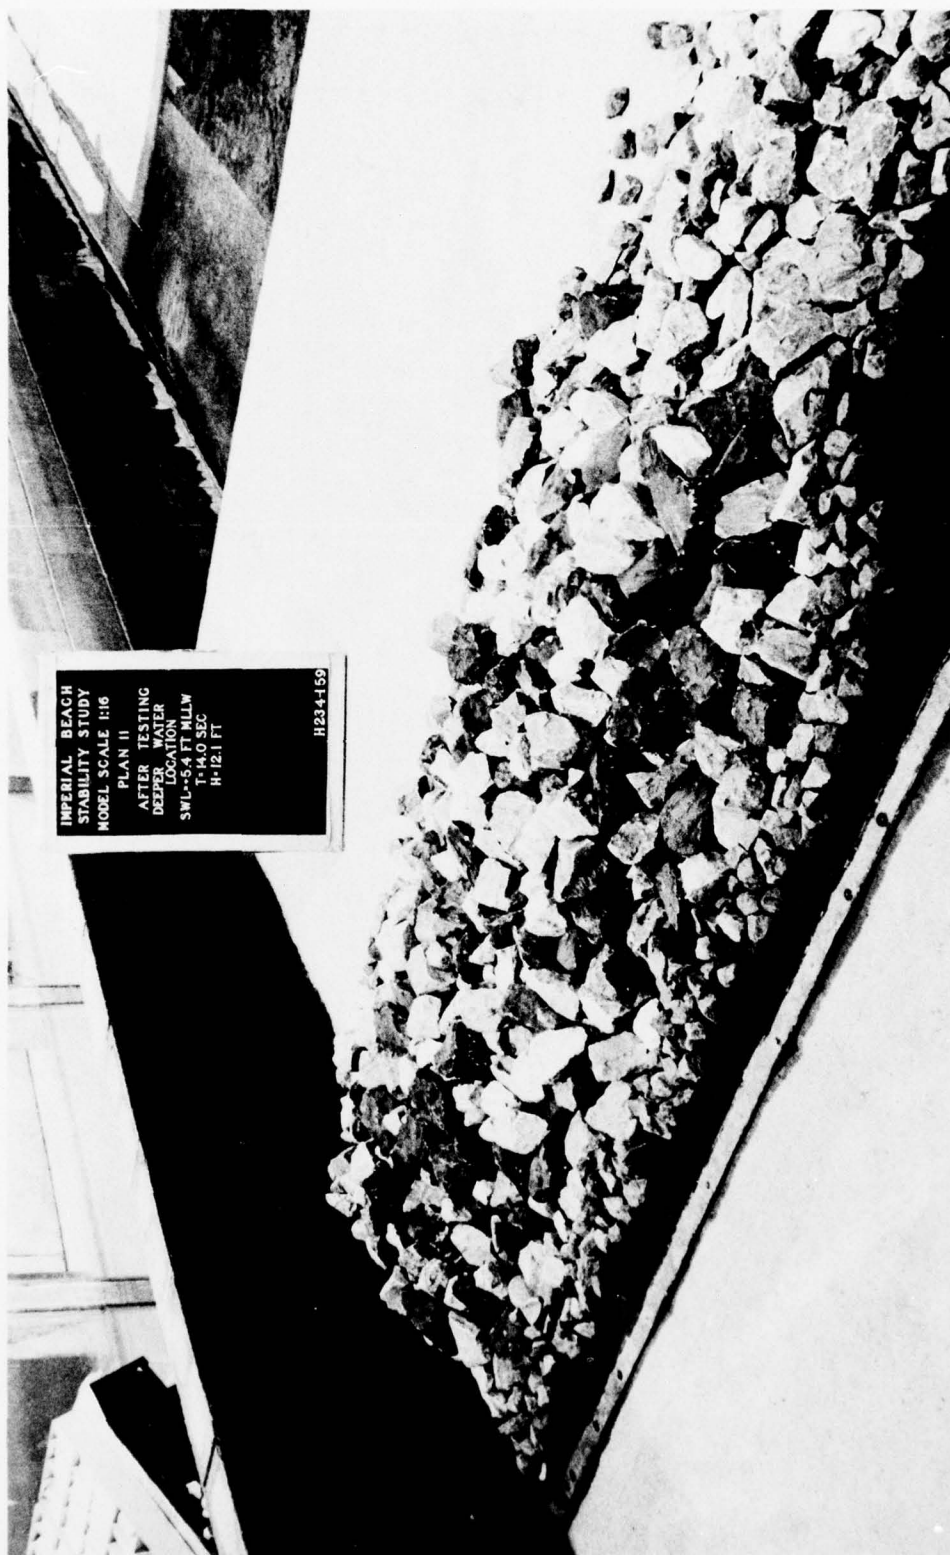
Photo 57. Sea-side view of high-sill section of Plan 11 in the deeper water location after 6.0 hr of 14.0-sec, 12.1-ft waves at an swl of +5.4 ft mllw

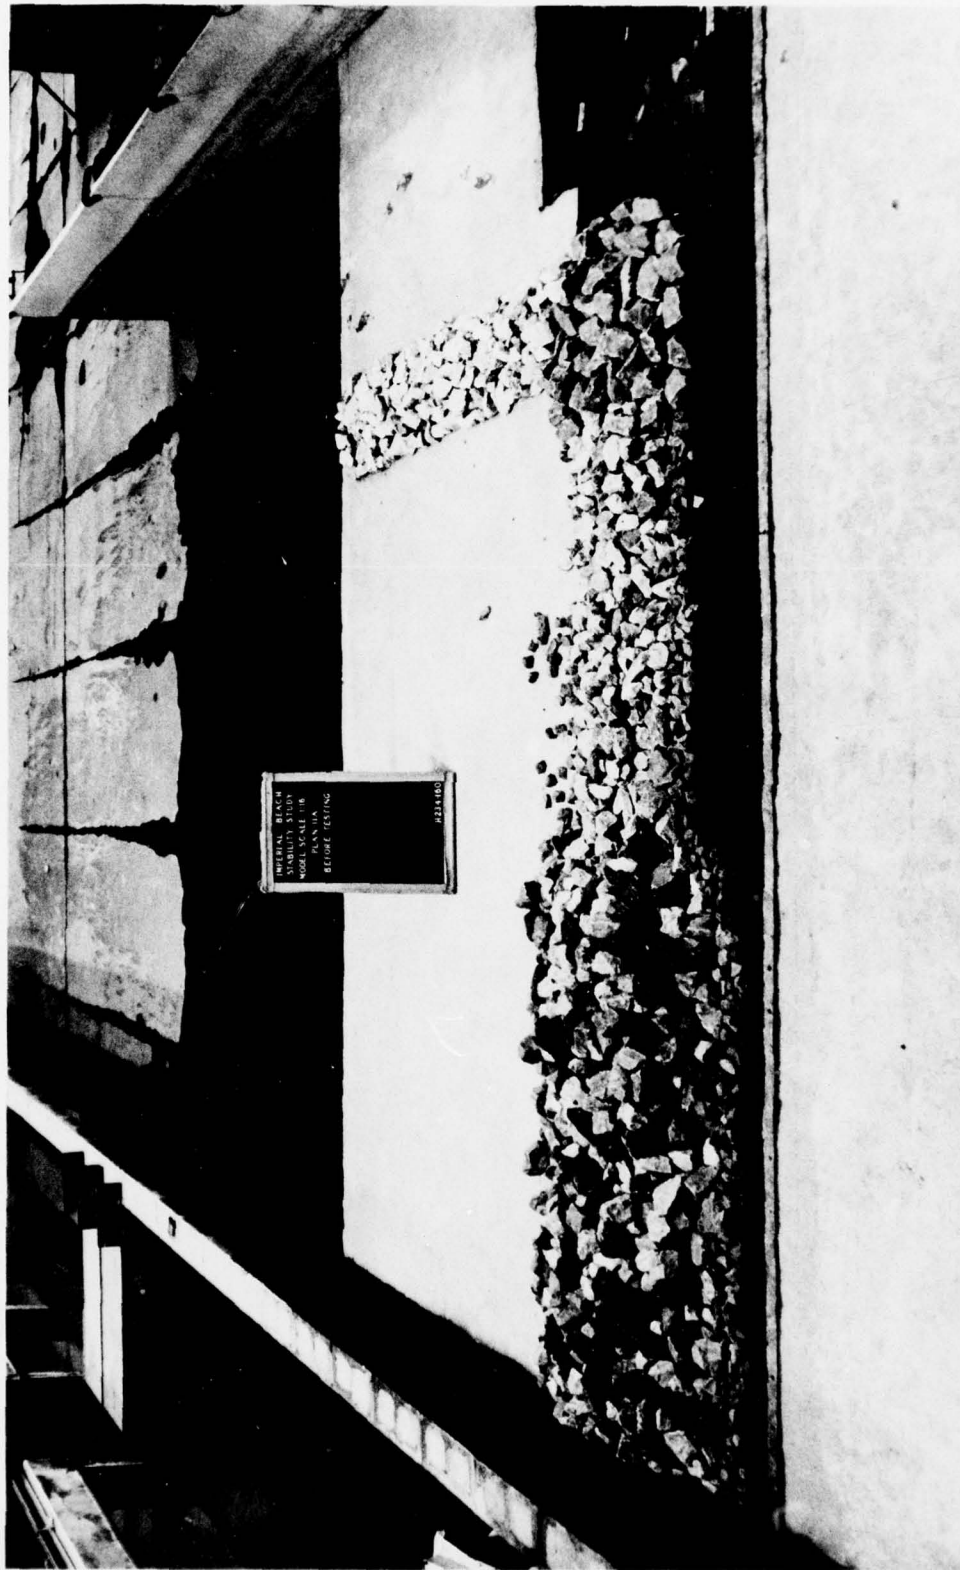
Photo 58. Sea-side view of Plan 11A before wave attack

27. Plan 11A (Plate 16 and Photo 58) was identical with Plan 11 (paragraph 26) except for the addition of the 5-ft-high beach-connected groin, constructed at a 90° angle to and connected to the low-sill head. The 5-ton graded armor stone mix, identical with that used on the low-sill trunk, was placed on 1V-on-2H slopes with a constant crown width of 10 ft. The groin crown elevation was not held constant but instead the structure height was maintained at 5 ft. In changing from Plan 11 to Plan 11A, only the low-sill head was rebuilt. In order to observe the result of extended wave attack, the remaining sections of the breakwater were not rebuilt during the change to Plan 11A. After 1.0 hr of attack by 14.0-sec, 12.1-ft waves at an swl of +5.4 ft mllw, the entire breakwater showed only minor damage which had stabilized before conclusion of the test (Photo 59).

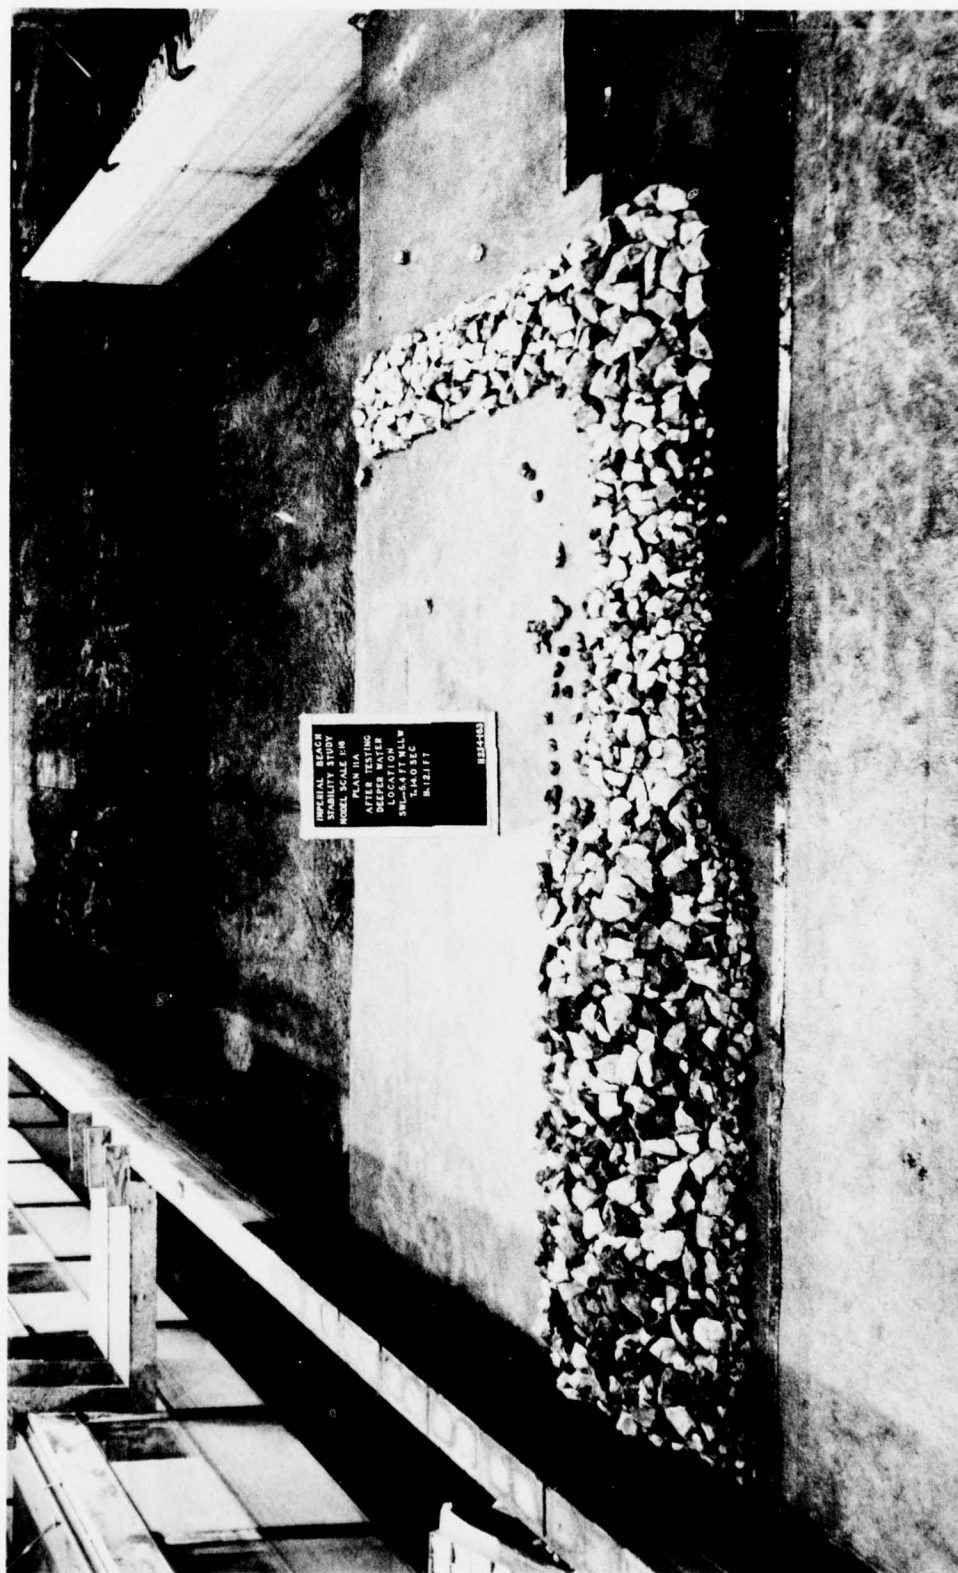
Photo 59. Sea-side view of Plan 11A in the deeper water location after 1.0 hr on 5-ft-high groin and low-sill head and 7.0 hr on remainder of breakwater of 14.0-sec, 12.1-ft waves at an swl of +5.4 ft mllw

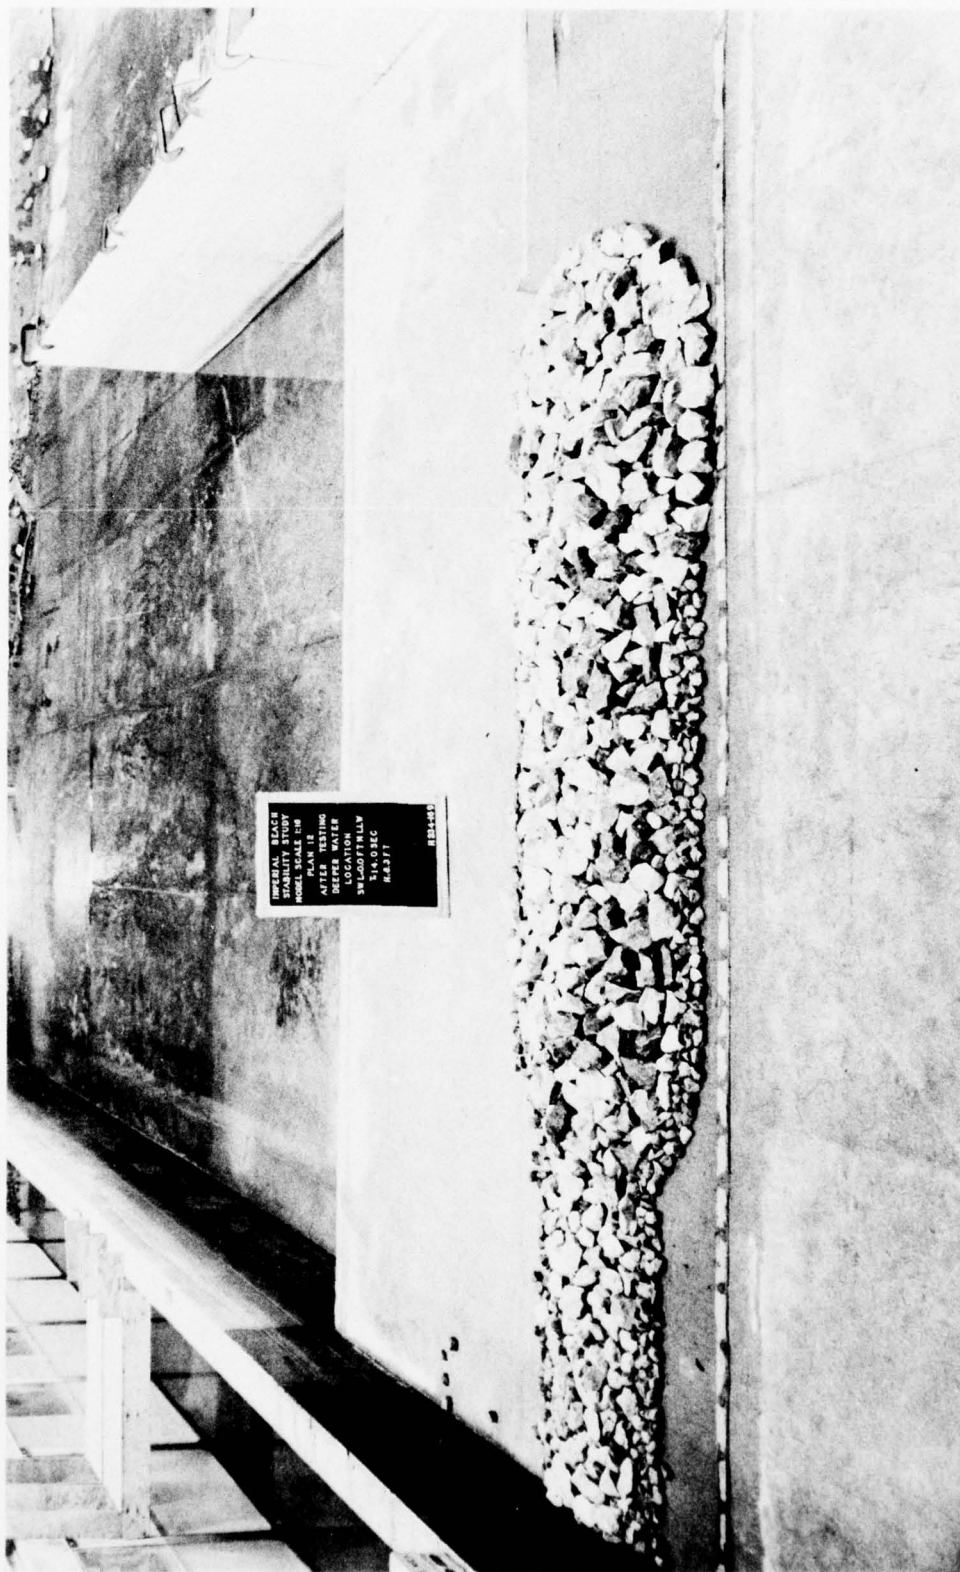
Photo 61. Sea-side view of Plan 12 in the deeper water location after 1.0 hr of 14.0-sec, 8.3-ft waves at an swl of 0.0 ft mllw

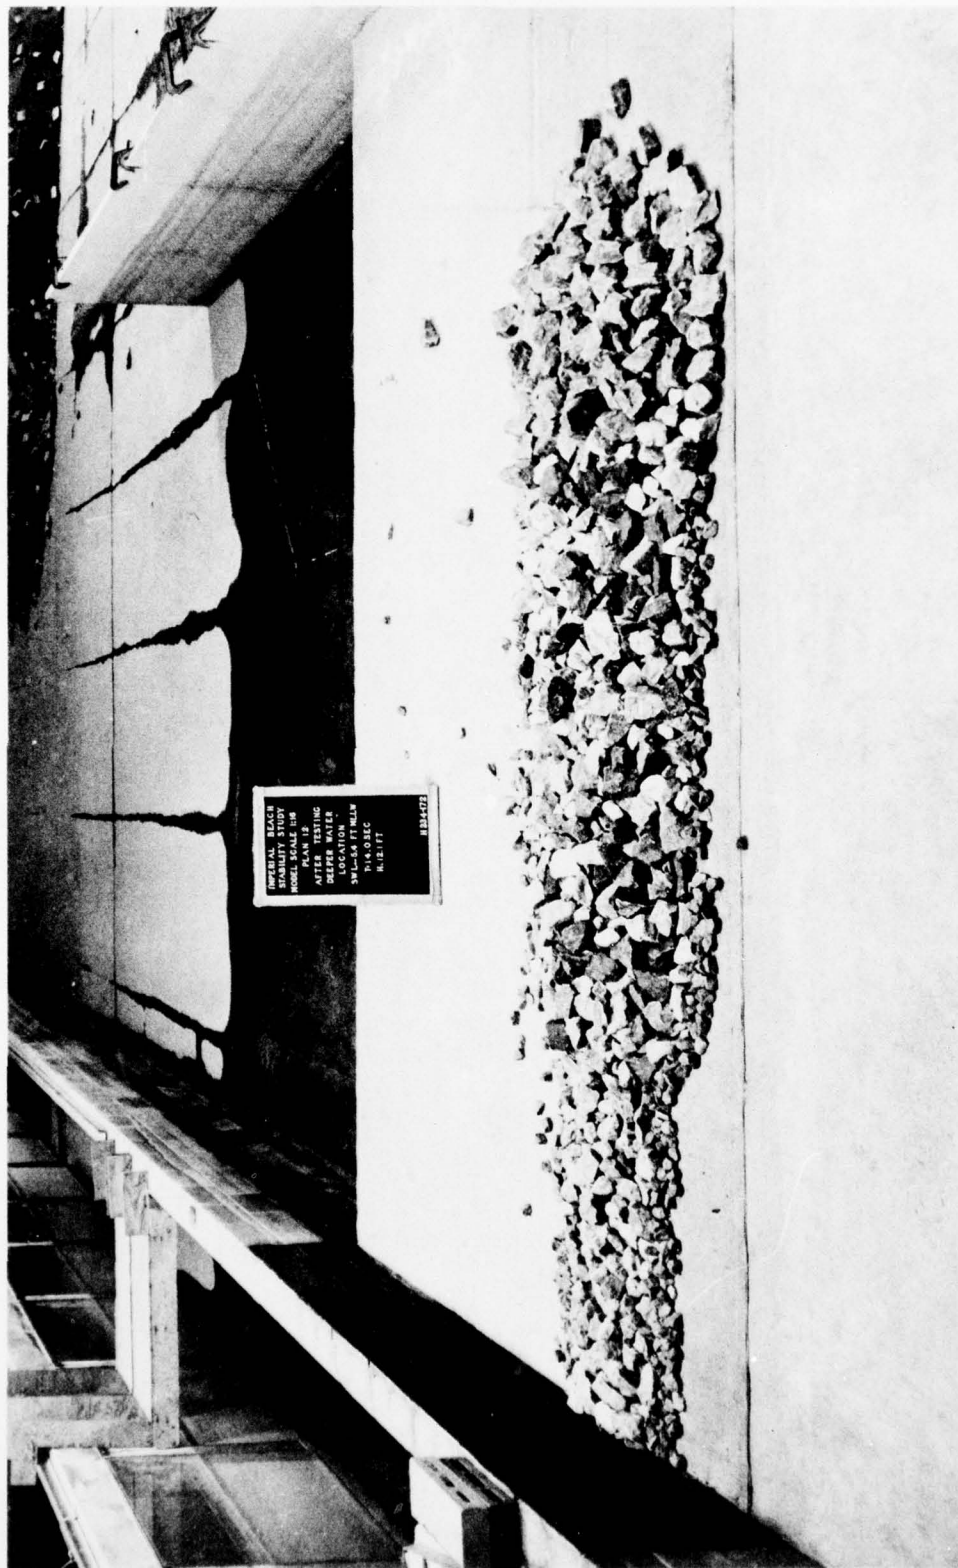
Photo 62. Sea-side view of Plan 12 in the deeper water location after 2.0 hr of 14.0-sec, 12.1-ft waves at an swl of +5.4 ft mllw

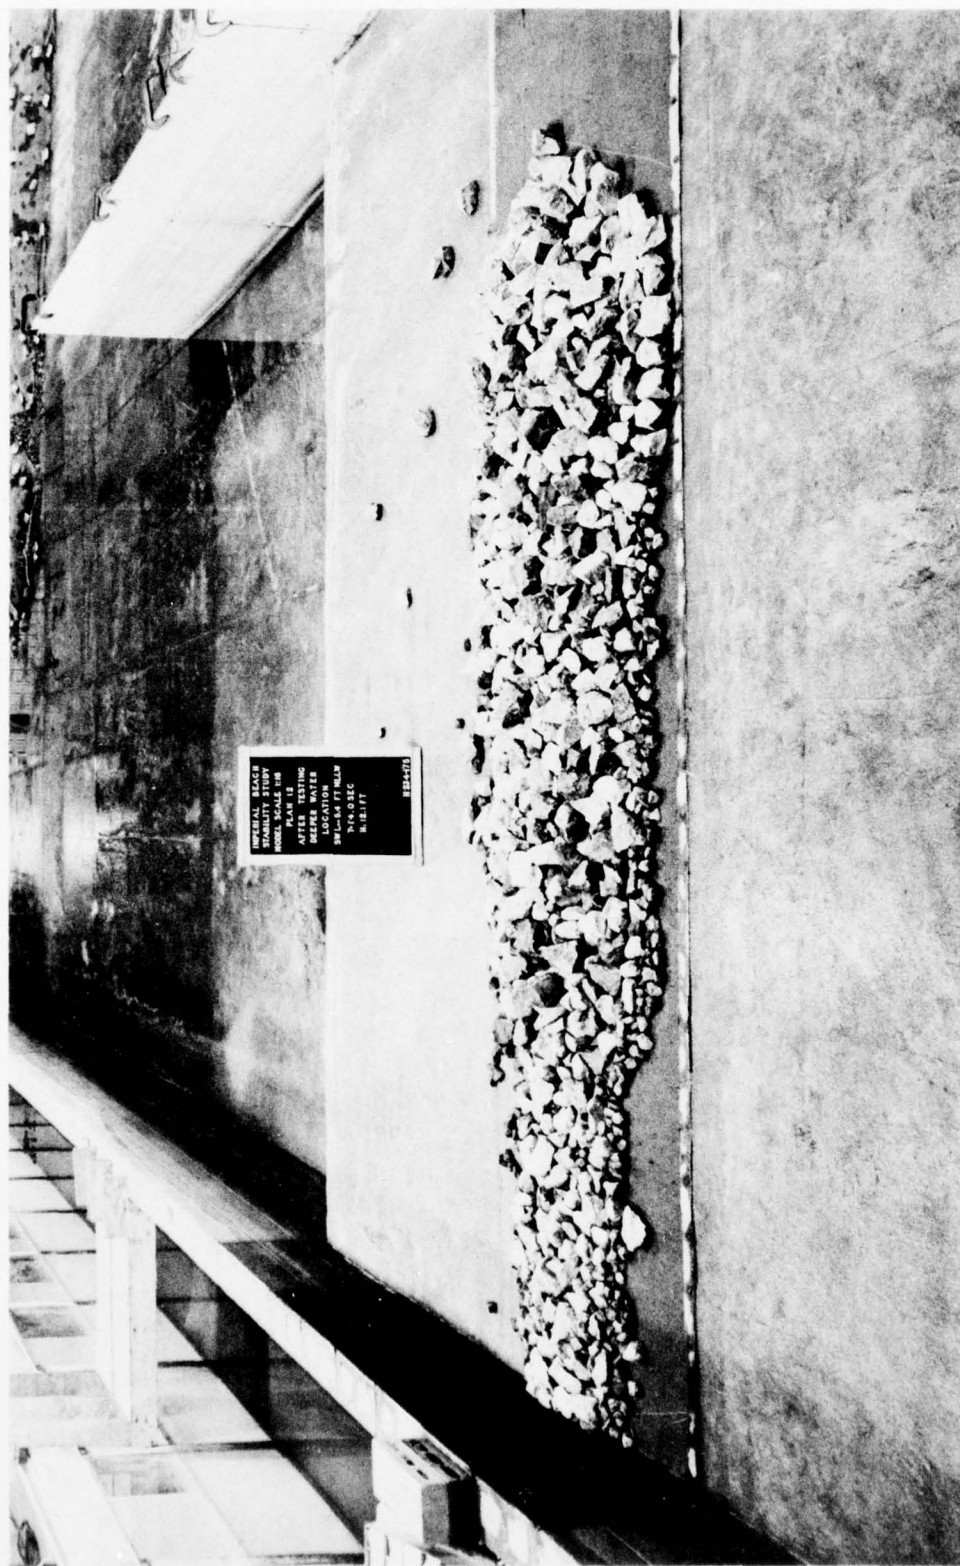
Photo 63. Sea-side view of Plan 12 in the deeper water location after 4.0 hr of 14.0-sec, 12.1-ft waves at an swl of +5.4 ft mllw

28. Plan 12 (Plate 17 and Photo 60) was a repeat test for the high-sill section and low-sill trunk of Plan 11. The alternating high and low sills of Plan 11 were reversed during construction of Plan 12 so that a 1V-on-3H slope high-sill head could be constructed at the end of the 1V-on-2H slope high-sill trunk. Construction of the high-sill head was identical with Plan 8 (paragraph 22) except that in Plan 8 the head had been attached to a high-sill trunk with 1V-on-3H slopes. Crown elevations were identical with those of Plan 11. After 1.0 hr of exposure to 14.0-sec, 8.3-ft waves at an swl of 0.0 ft mllw, the structure had experienced very minor damage (Photo 61). The test condition was changed to 14.0-sec, 12.1-ft waves at an swl of +5.4 ft mllw and after 2.0 hr of wave attack, only minor damage was observed (Photo 62). The identical test conditions were extended and after a total of 4.0 hr of wave attack the breakwater had accrued minor to moderate damage (Photos 63-65).
